An Overview of 2019 IMPROVE Sampler Technical System Audits

February 27, 2020

CIRA

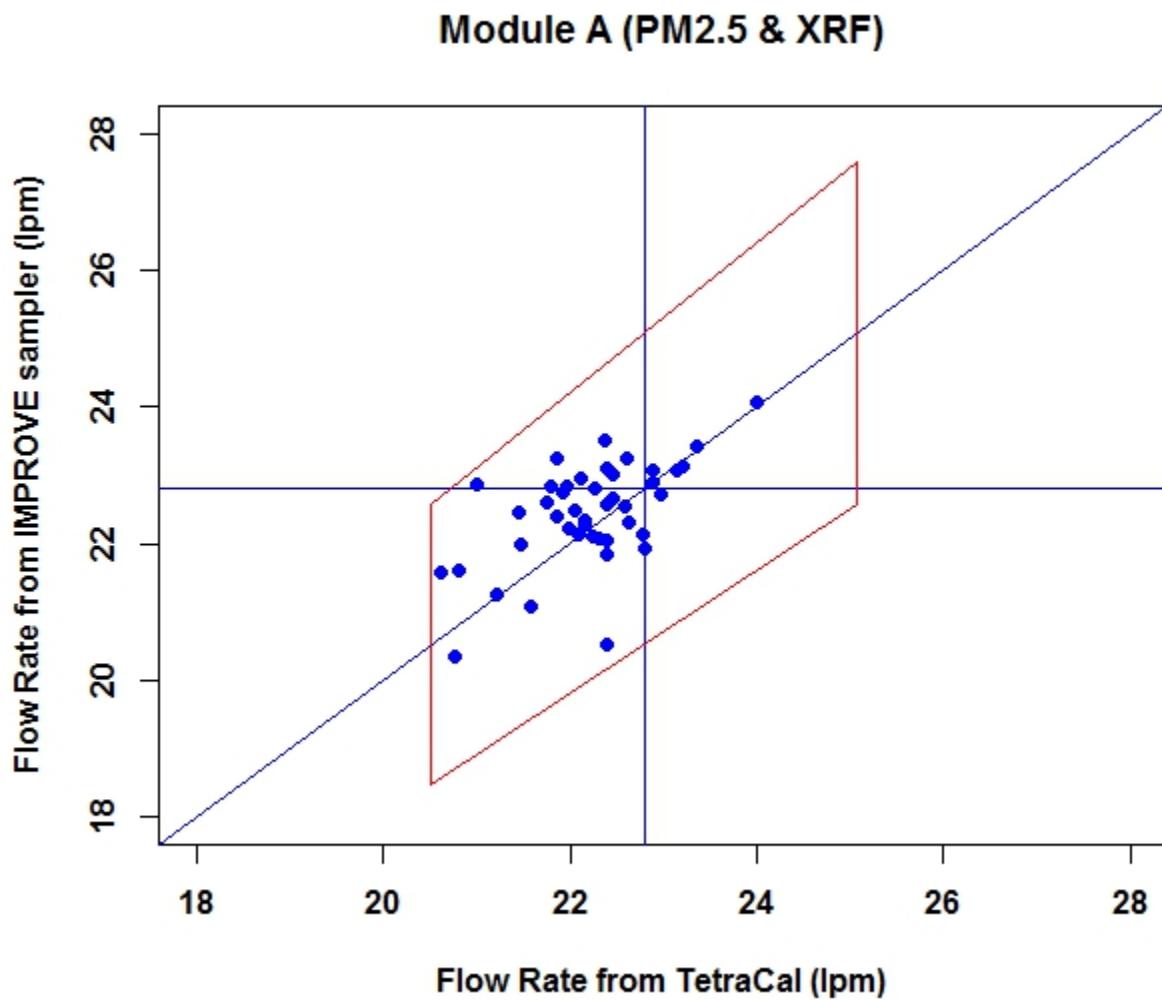
Figure 2. Module A flow rate comparisons between audit device and IMPROVE sampler for audits conducted in 2019.

Stat	A_Audit (lpm)	A_CYC (lpm)	%Diff	Nomdiff
Min	20.61	20.33	0.09647	0.000
1st Qu	21.86	22.10	0.78088	1.645
Median	22.27	22.54	2.36792	2.500
Mean	22.20	22.44	2.45908	3.213
3rd Qu	22.59	22.92	3.80528	4.276
Max	24.00	24.07	8.91033	9.605

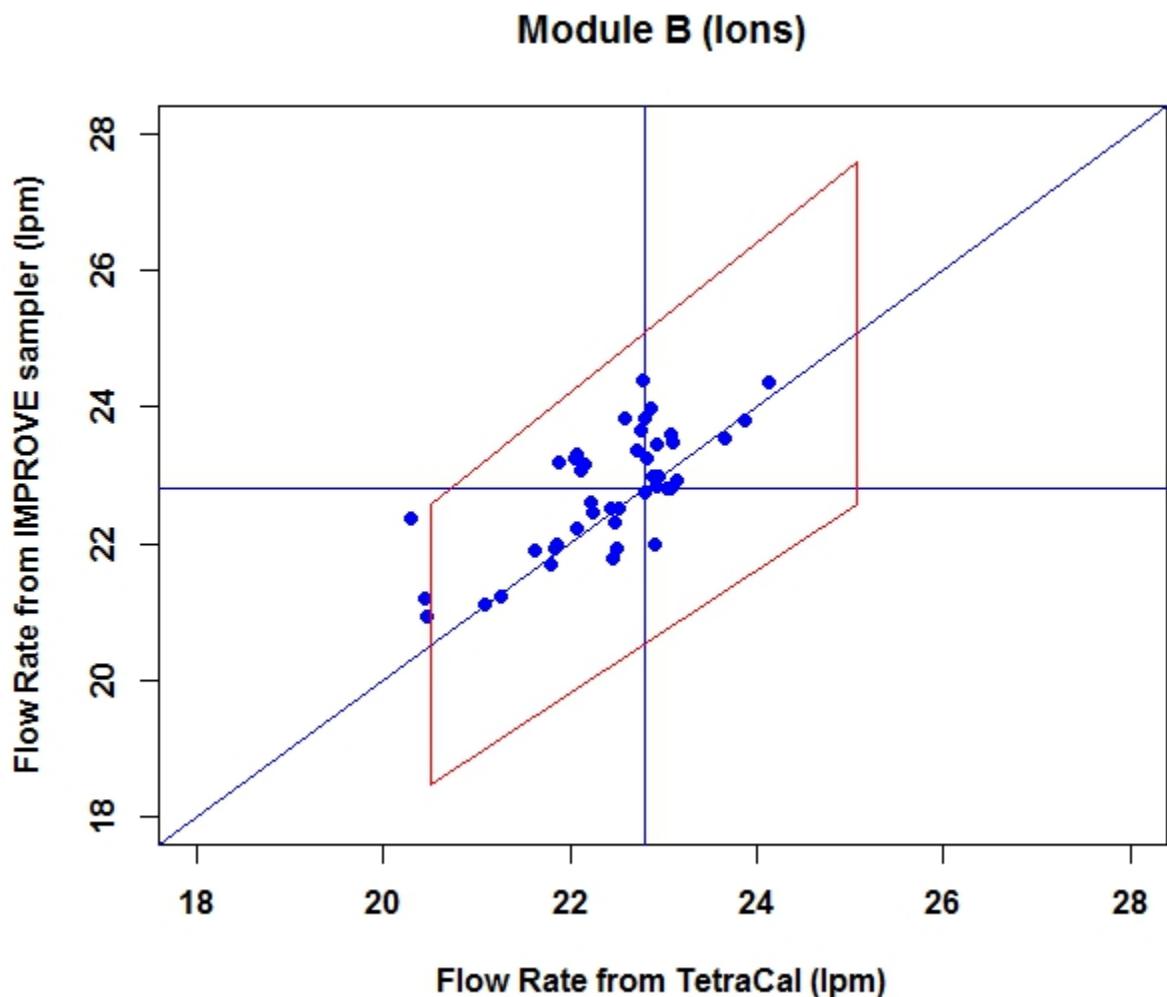
Figure 3. Module B flow rate comparisons between audit device and IMPROVE sampler for audits conducted in 2019.

Stat	B Audit (lpm)	B CYC (lpm)	%Diff	Nomdiff
Min	20.30	20.94	0.0444	0.000
1st Qu	22.06	22.10	0.4695	0.636
Median	22.53	22.85	1.6916	1.491
Mean	22.41	22.77	2.3584	2.800
3rd Qu	22.91	23.41	3.9591	4.035
Max	24.14	24.40	10.1091	10.965

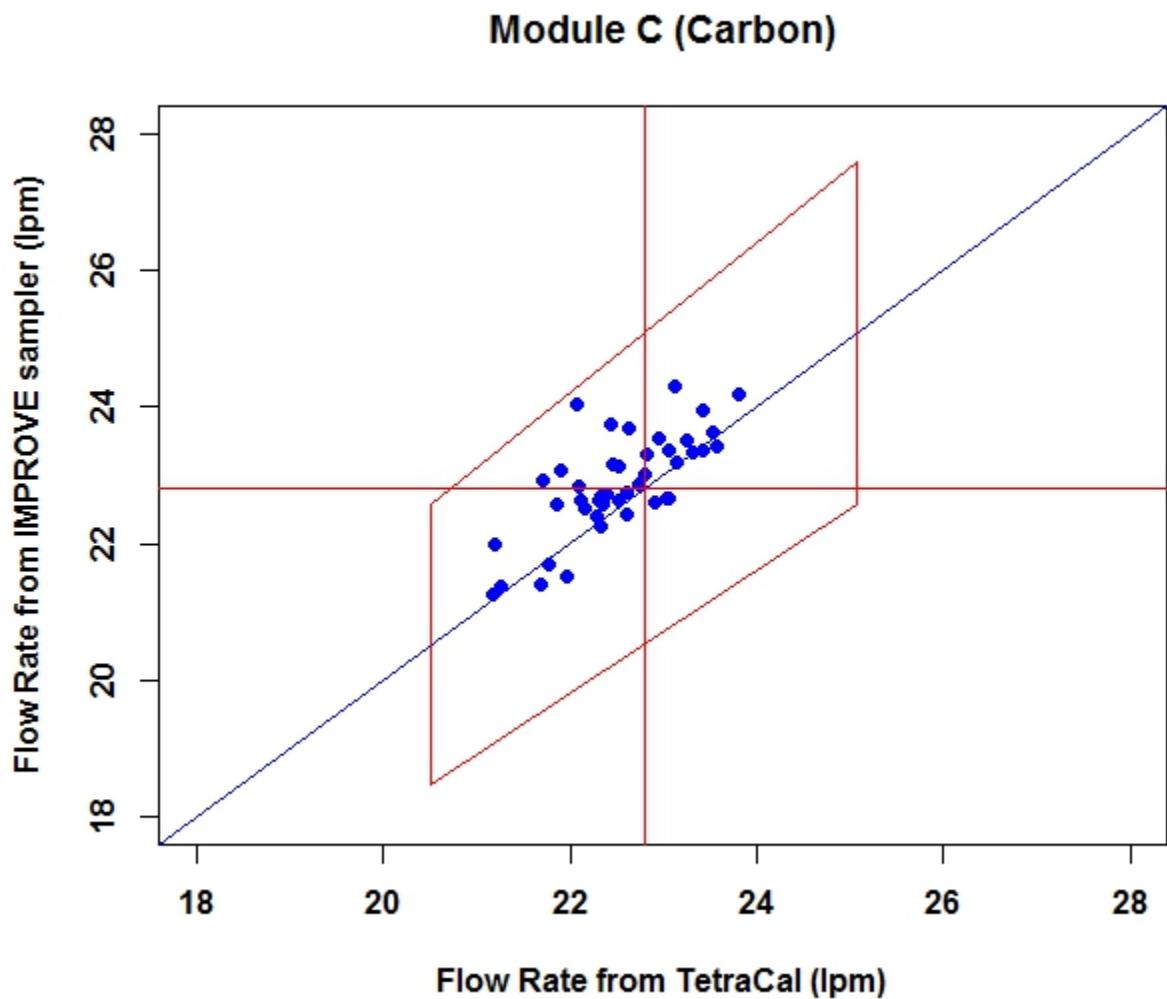
Figure 4. Module C flow rate comparisons between audit device and IMPROVE sampler for audits conducted in 2019.

Stat	C Audit (lpm)	C CYC (lpm)	%Diff	Nomdiff
Min	21.18	21.25	0.01864	0.04386
1st Qu	22.11	22.58	0.55207	1.18421
Median	22.52	22.83	1.48968	2.06140
Mean	22.53	22.87	2.02109	2.50408
3rd Qu	23.04	23.36	2.60041	3.31140
Max	23.80	24.30	8.81928	7.10526

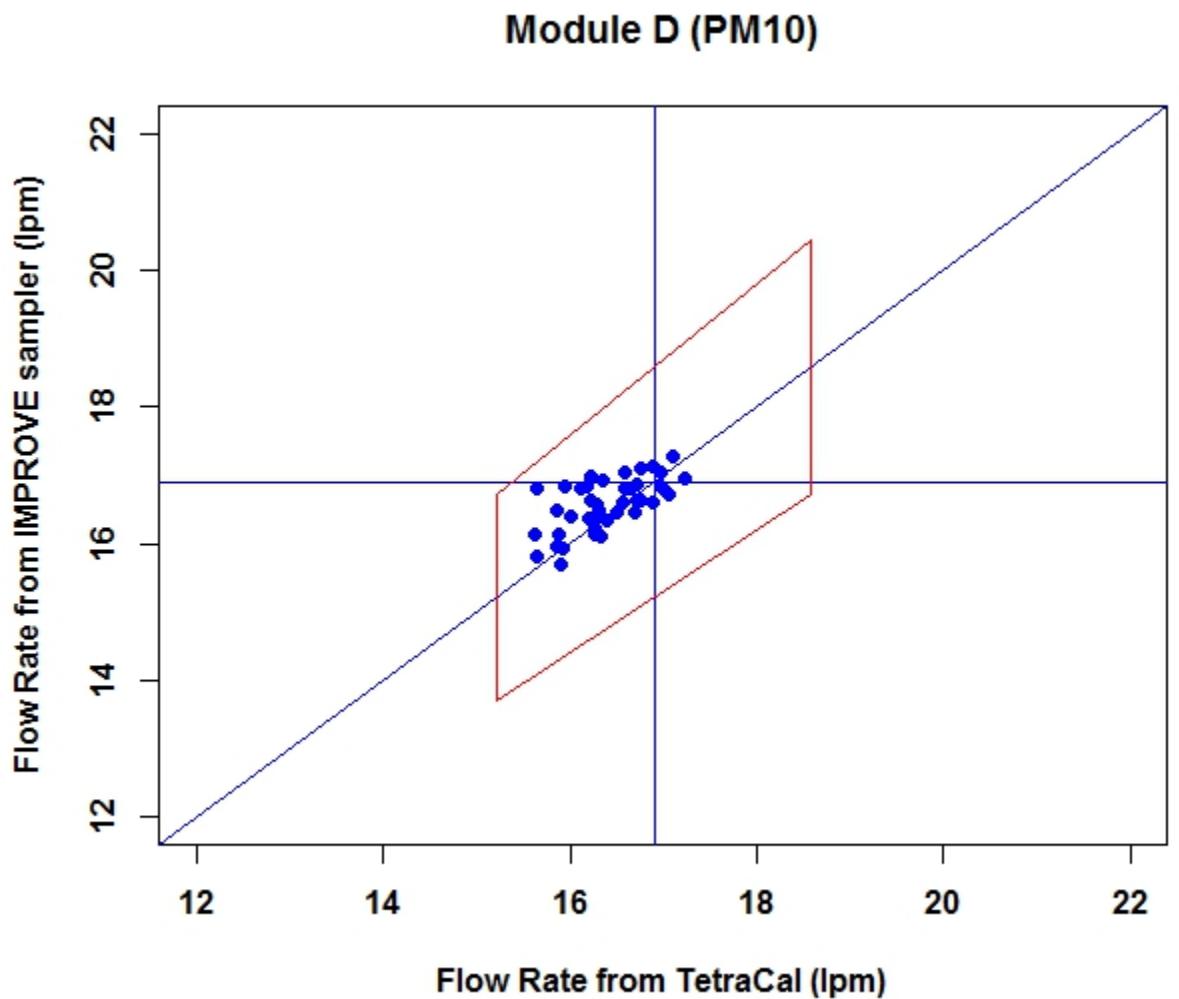
Figure 5. Module D flow rate comparisons between audit device and IMPROVE sampler for audits conducted in 2019.

Stat	D Audit	D CYC	%Diff	Nomdiff
Min	15.63	15.68	0.03233	0.05917
1st Qu	16.14	16.36	0.80161	1.21302
Median	16.33	16.63	1.39467	3.37278
Mean	16.40	16.57	1.78487	3.20077
3rd Qu	16.71	16.83	2.16508	4.46746
Max	17.23	17.27	7.29840	7.51479
